Quick report on dams

April 4th, 2011

JCOLD

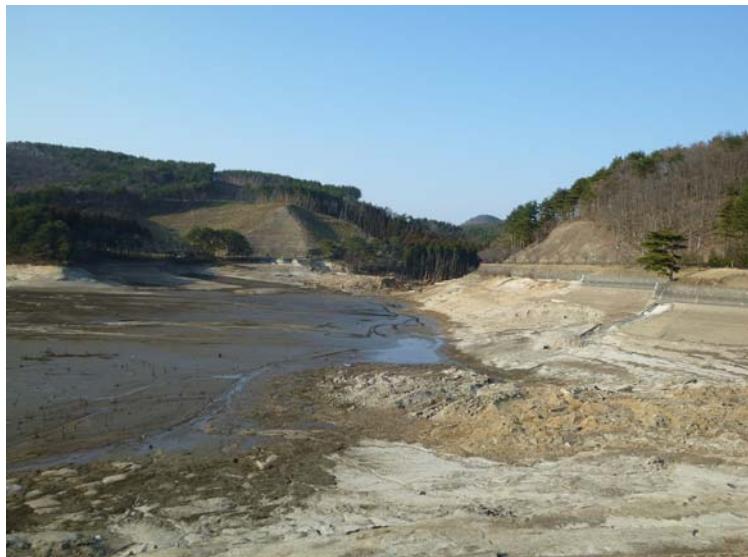
Photo 1 View from upstream toward the Fujinuma-ike (Photo: Mastumoto)

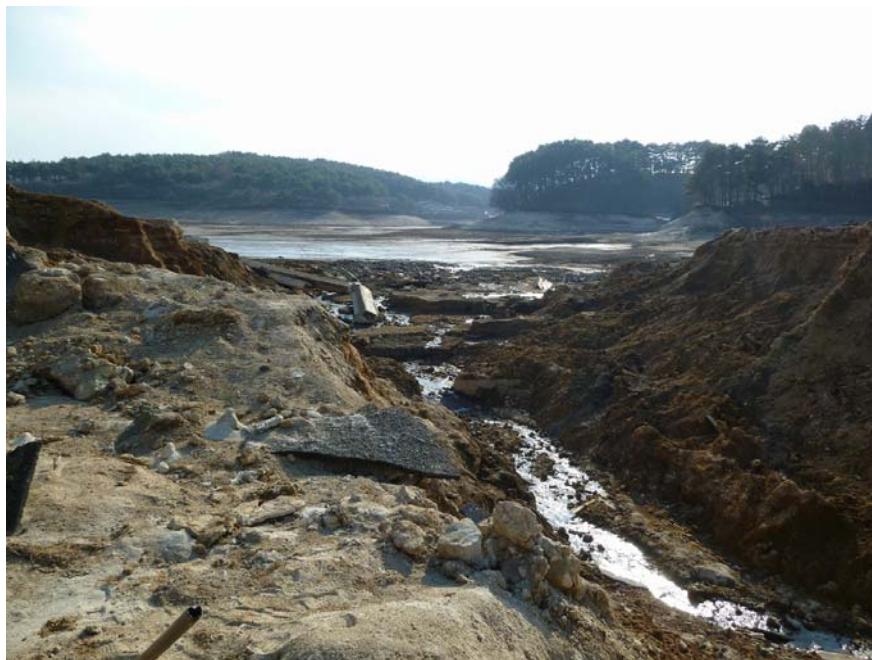
Photo 2 View from downstream toward the main breached portion
(Photo: Matsumoto)

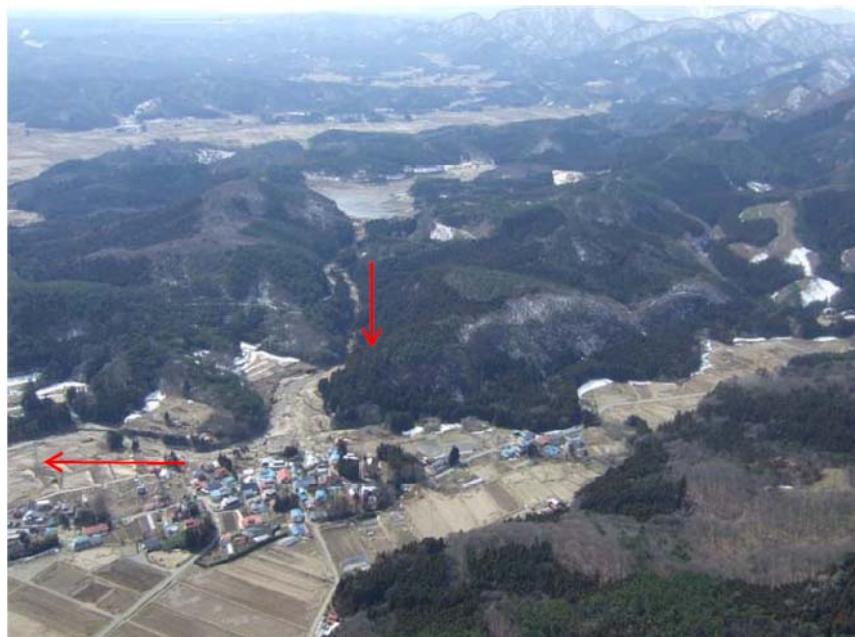
Construction began in 1937 for irrigation and was suspended during World War 2. It was completed in 1949. When the earthquake occurred, the reservoir level was almost full. According to the witness, 20 to 25 minutes after the earthquake, the water was overflowing on the crest. Later big discharge occurred and it was breached completely as shown in Photos 1 & 2. The embankment had lost the height to retain water. The structure is a homogeneous type and most materials seem to be cohesive soil. The authority concerned will investigate the cause of the failure and make the report public. In Photo 3, red lines indicate the path of flow.

Photo 3 Arial view of Fujinuma-ike and its downstream area (Photo: NILIM²)
