The 2011 Tohoku Earthquake and Dams

ICOLD 89th Annual Meeting in Lucerne
June 1, 2011

Japan Commission on Large Dams
N. Matsumoto, T. Sasaki & T. Ohmachi

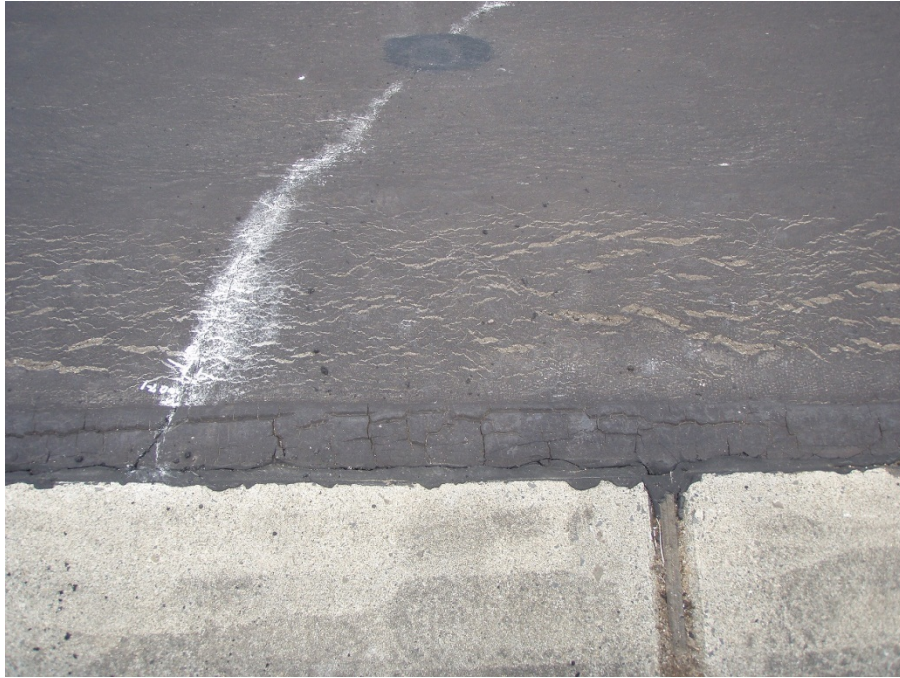
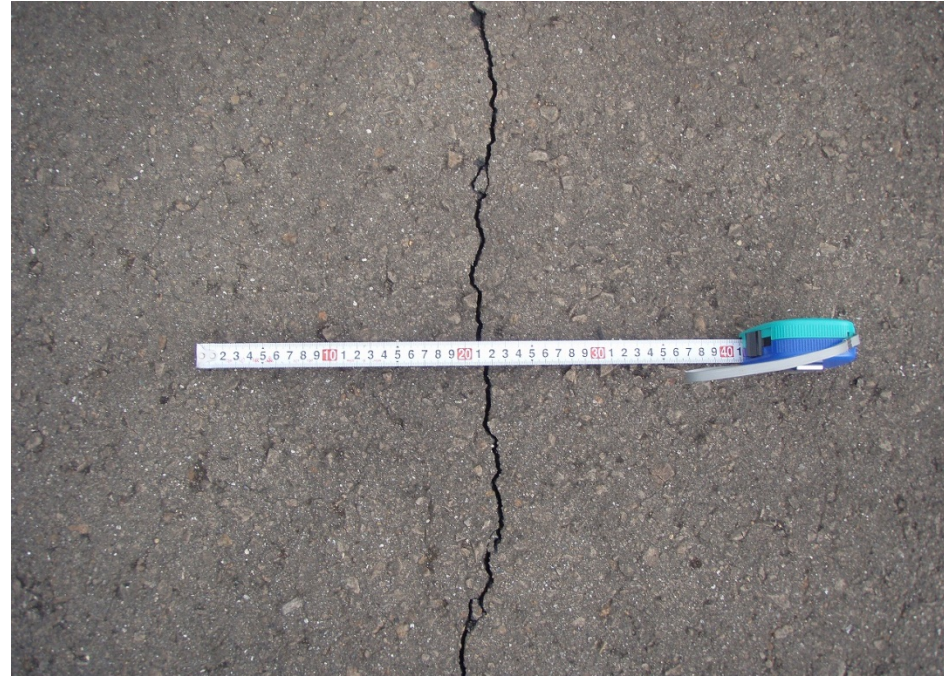
Cracking on the asphaltic concrete face --the width is 3 mm.

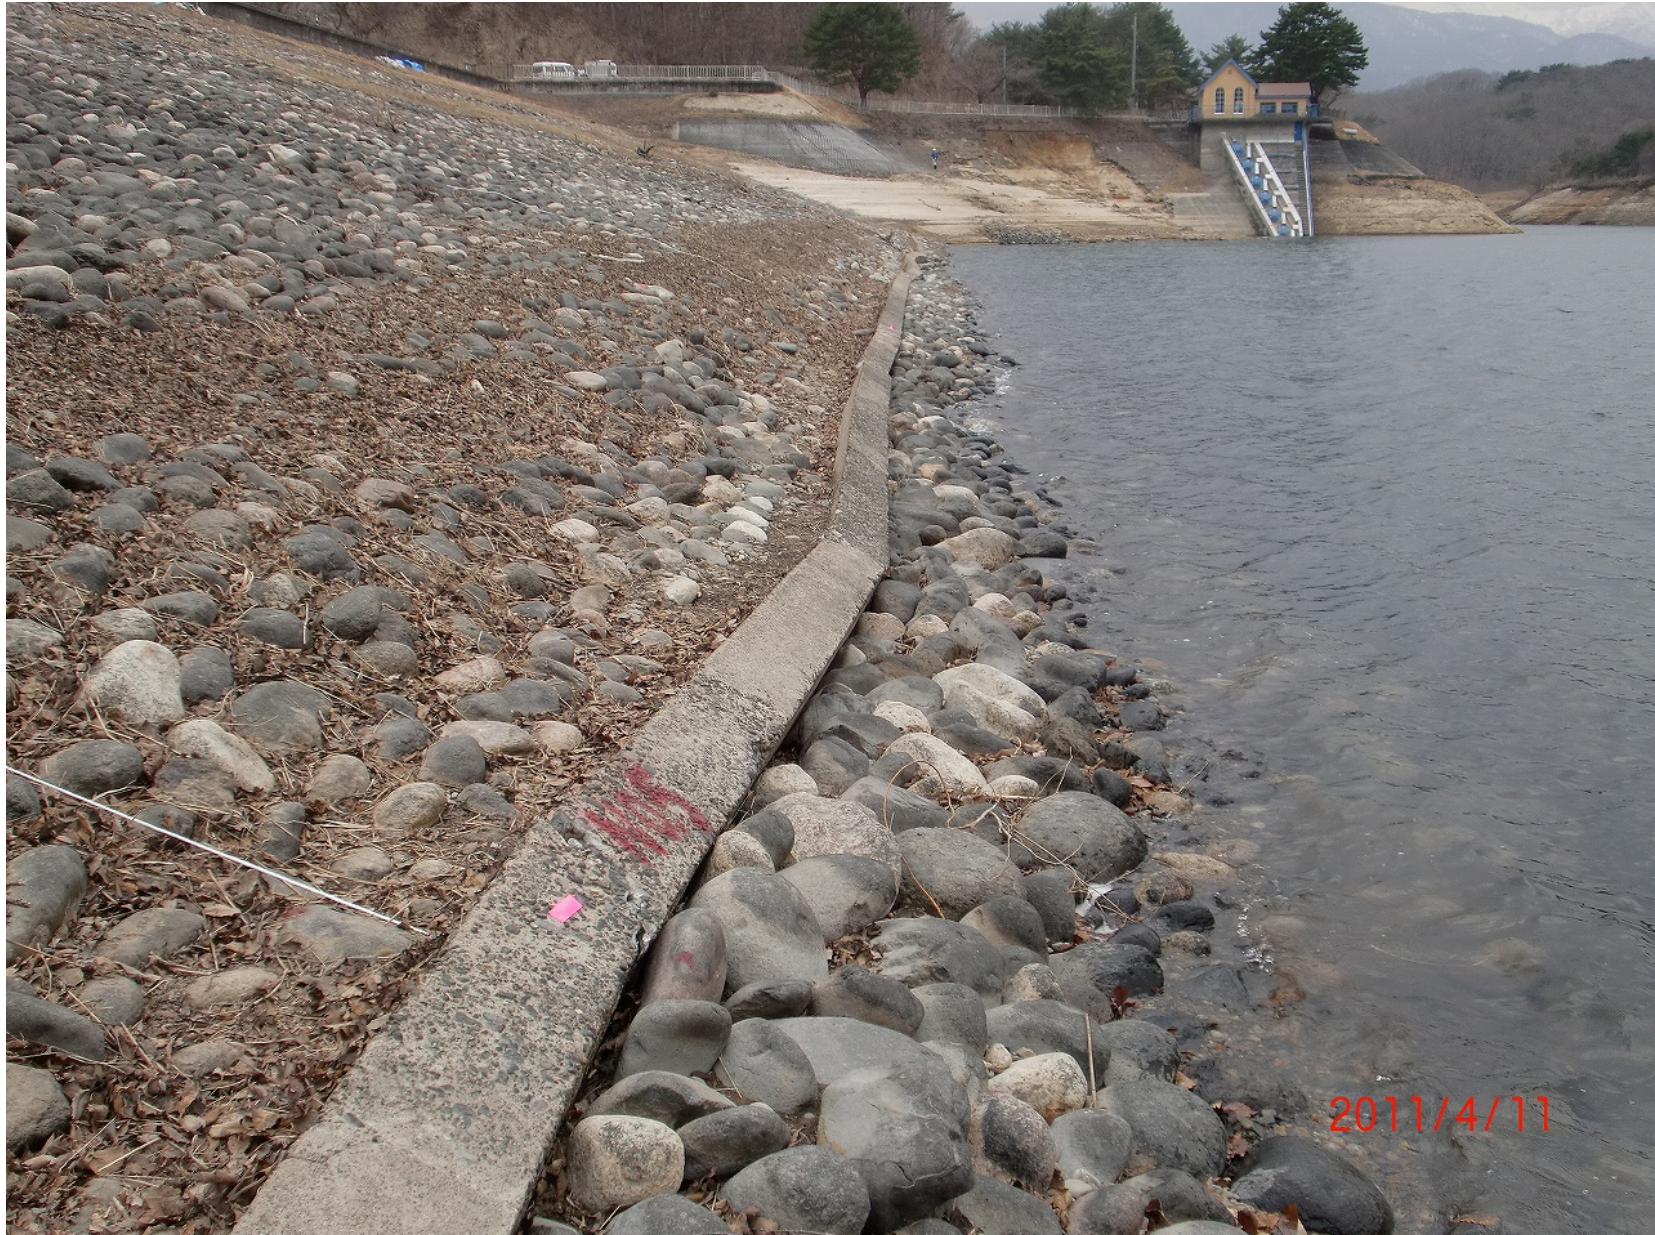
Nishigo Dam April 11, 2011

one month after the event, drawdown of water

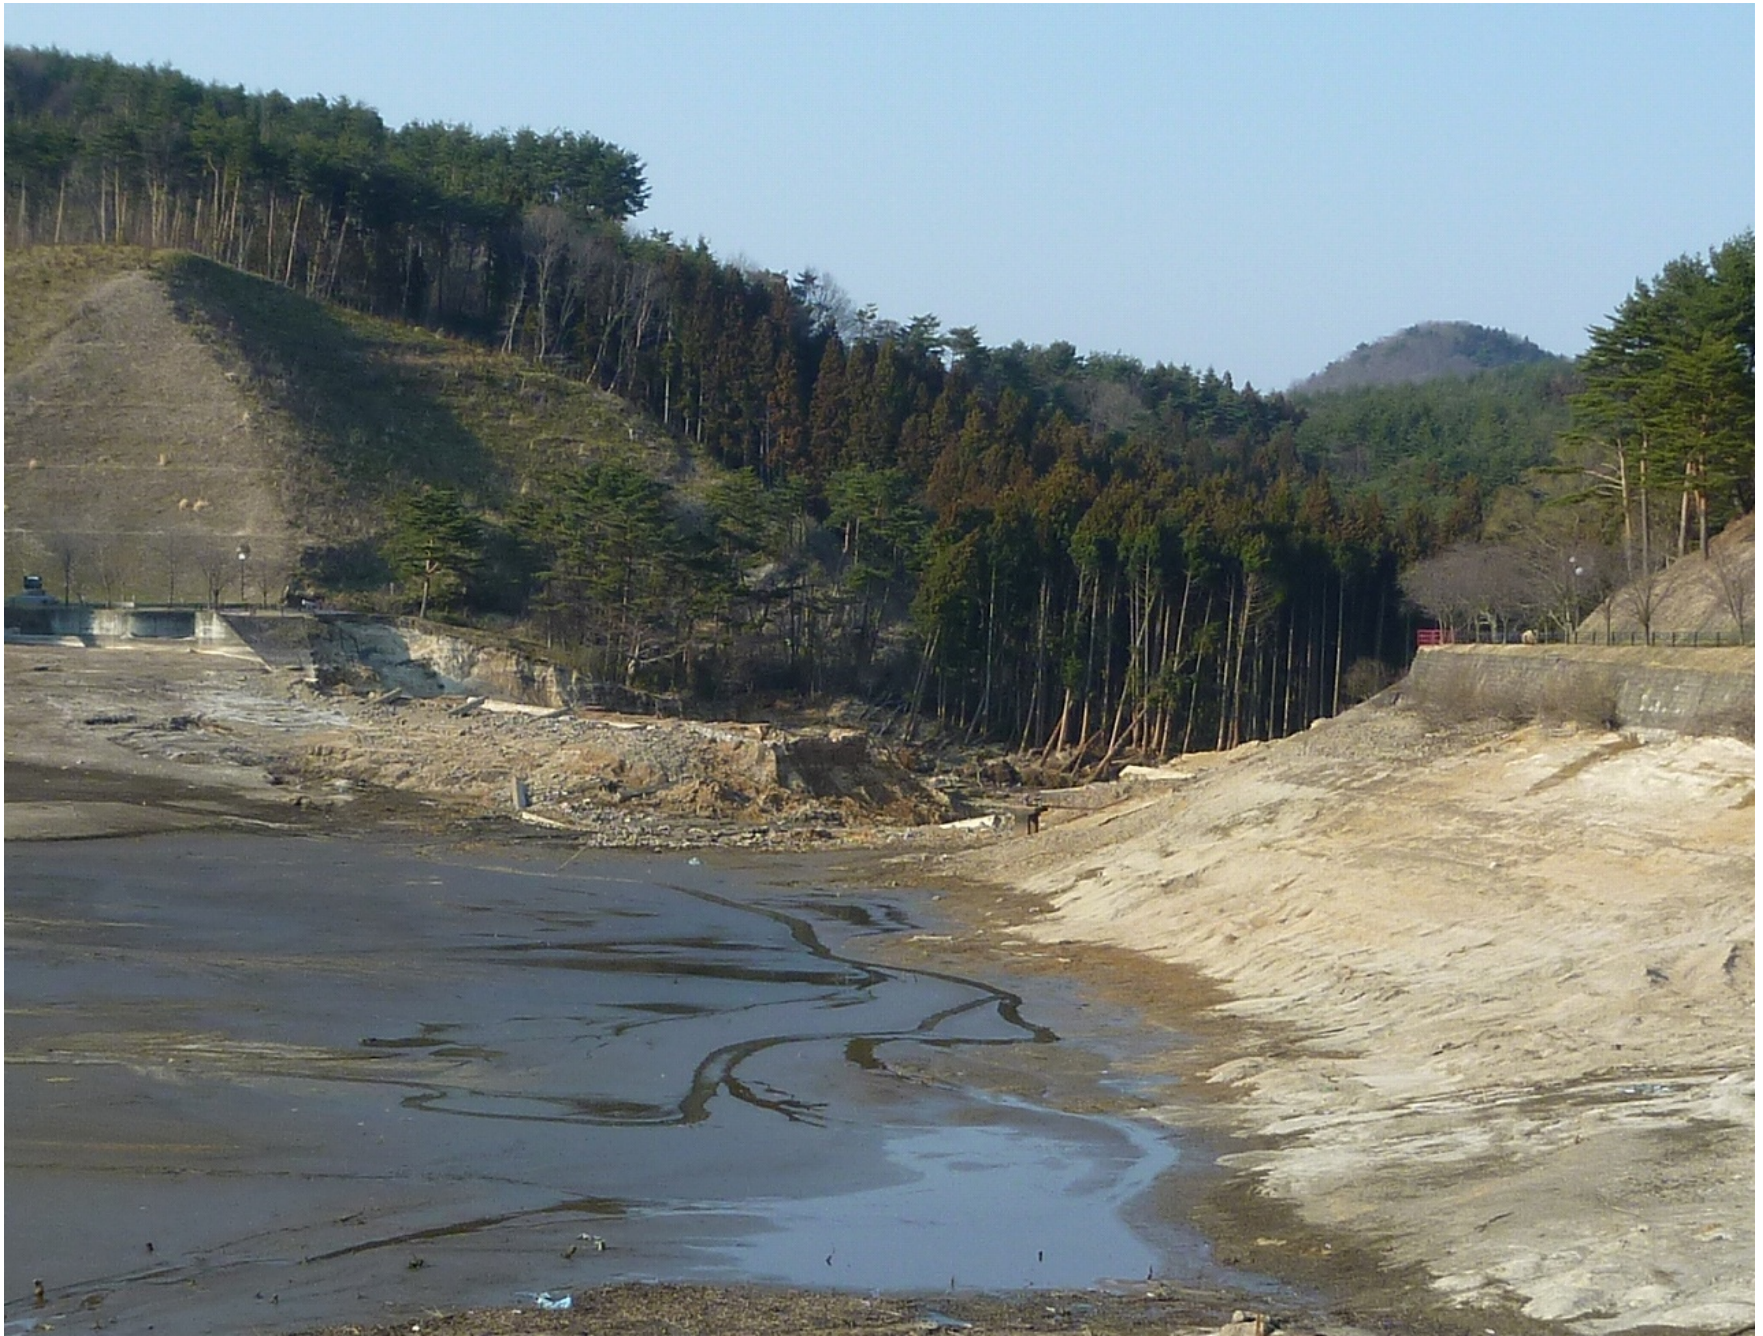
Fujinuma-ike after breach

Fujinuma-ike was breached shortly after the earthquake. It was an earthfill type embankment with the height of 18.5 m and the length of 133 m. The reservoir capacity was 1.5 million m³.
