Review of the Cause of Fujinuma-ike Failure

--Summary Report--

January 25, 2012

Panel to evaluate the seismic stability of dams and small ponds for agricultural purpose of Fukushima Prefecture

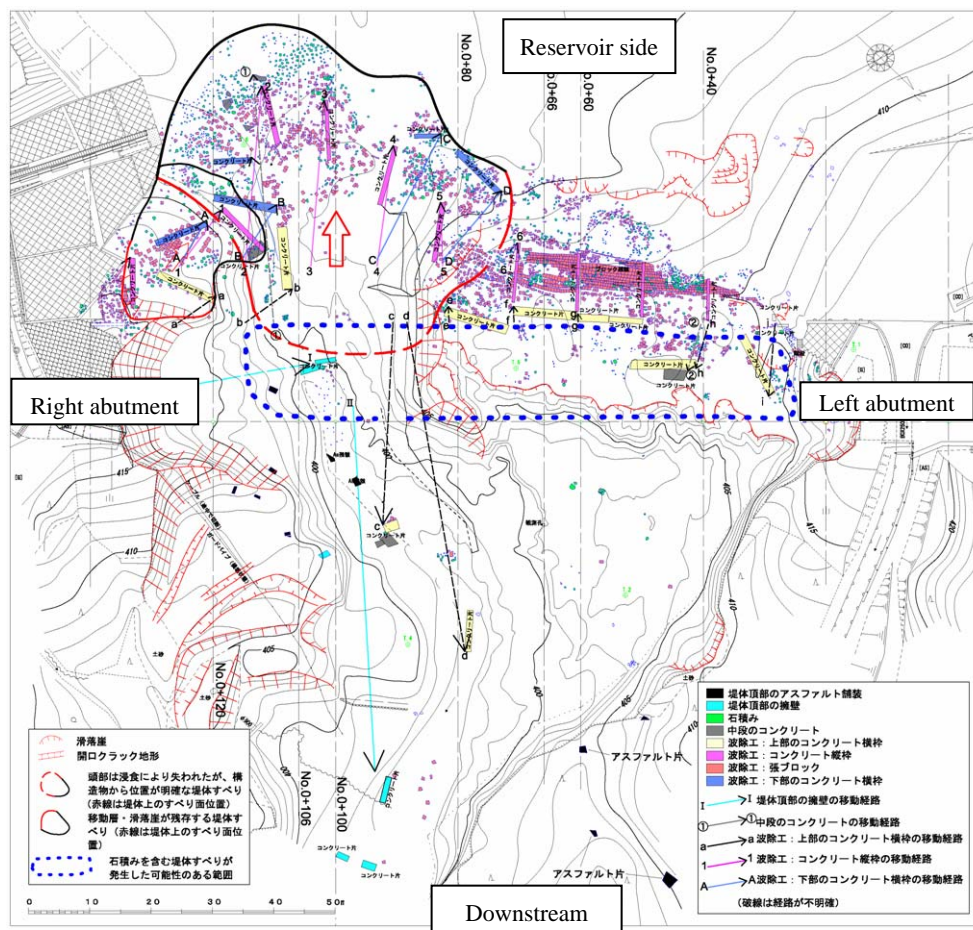
Figure 1. Mapping of structural elements after failure

- (1) Most of upper part of embankment was washed away and most of middle and lower part of downstream embankment was also washed away.
- (2) From the movement of the structural elements, firstly, masonry riprap of upper part of embankment fell to the reservoir and subsequently the surface protection work from the middle to the right abutment moved substantially to the reservoir (Figure 1).
- (3) It was confirmed that slides occurred in the direction both of the reservoir and downstream judging from the distribution of main scarps, sliding surfaces and moved layers in Fujinuma Dam (Figure 2).
- (4) In the auxiliary dam, the main slide with the width of 55 meter, length of 25 meter and depth of more than 3 meter occurred and the secondary slide happened at its front (Figure 3).

Notes: The dot colored blue is the parapet wall. The dot colored green is masonry riprap. The small square colored purple is the surface protection work. The rectangular colored yellow is concrete beam on the upper upstream slope. Most structural elements moved to upstream.

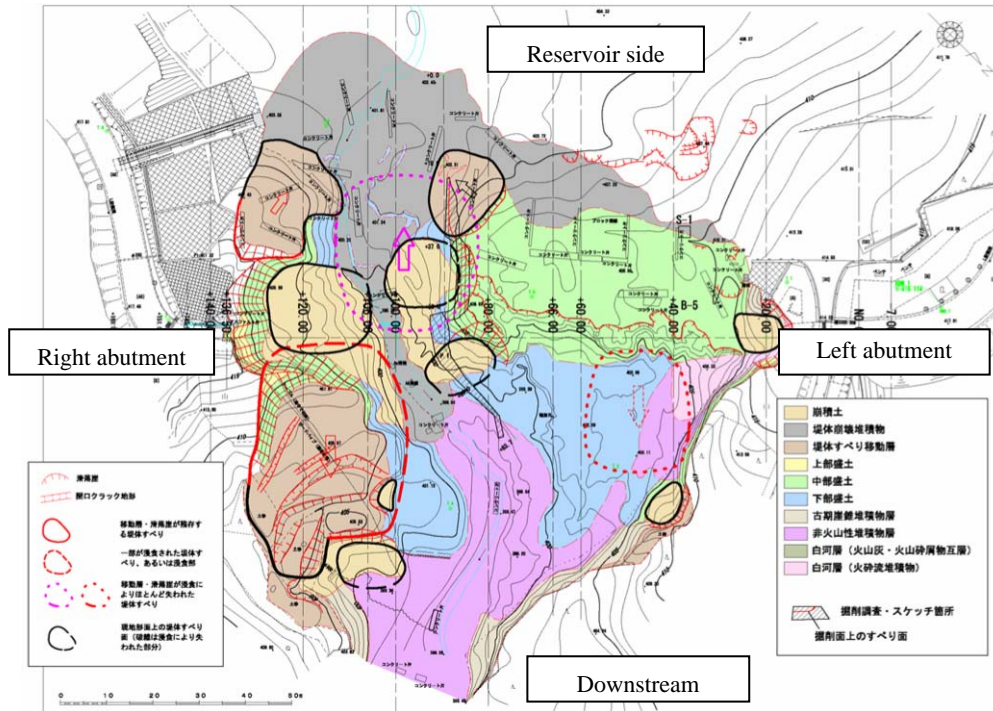
Figure 2. Possible slides estimated from geologic and topographic mapping

Notes: Encircled lines indicate the slide block.

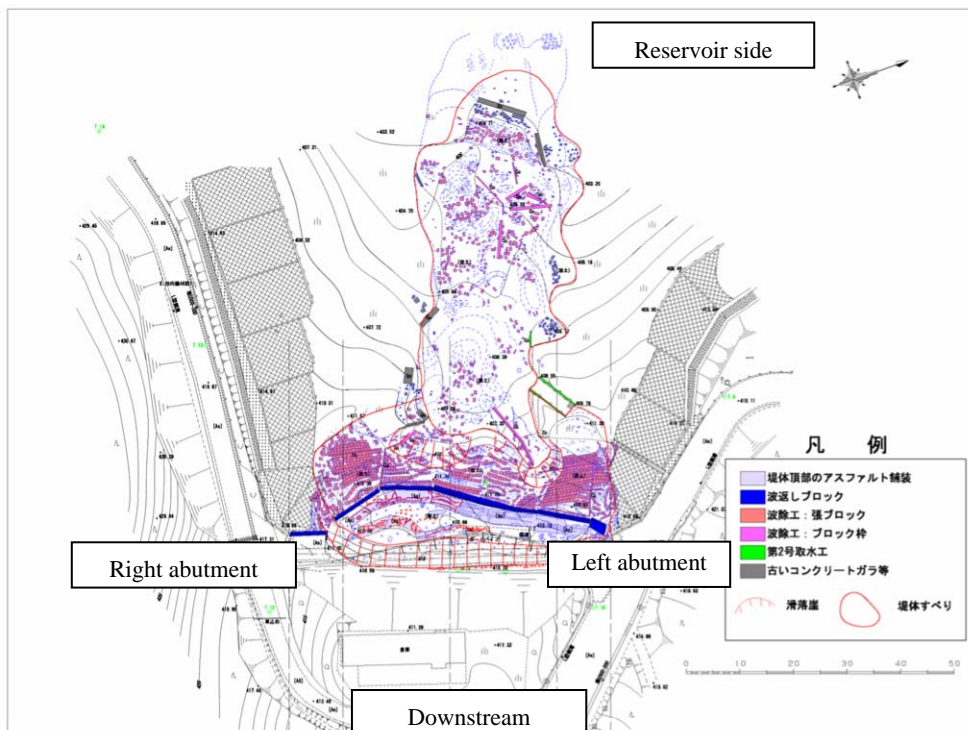
Figure 3. Damage of structure and slides of auxiliary dam

Notes: The area colored blue is concrete parapet wall. The small square colored purple is concrete block for surface protection work

(3) The slide occurred in the auxiliary embankment consisting of similar material to upper embankment of main dam and one of its failure causes is the nature of the soil of embankment, rich with sandy materials.

(4) In the slide occurred in the auxiliary dam, sliding surface was restricted to the embankment boundary of the different construction periods. In the main dam, the difference of the degree of compaction depending on the different construction periods is possibly attributable to the occurrence of the sliding.

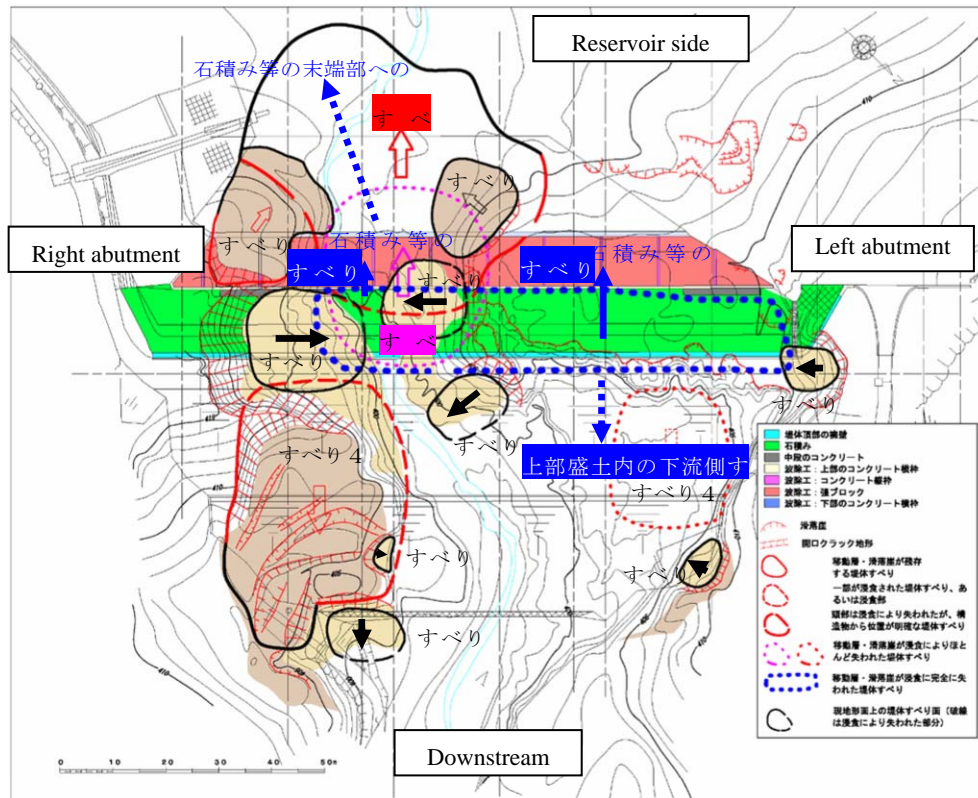
Figure 4. Integrated map of slides of Fujinuma main dam

Summing up the investigation results, slides are broadly classified to seven stages (Figure 4). Among these slides, the upstream slide No.1 and No. 2 triggered the subsequent overflow and erosion and resulted in a failure of the dam. The slide No.1 occurred in the upper embankment and it was recognized from the remnant of the structural elements in the reservoir and sliding surface was lost by wash-out. However, the earthquake deformation analysis (by modified Newmark procedure) considering the strength reduction due to cyclic loading indicated the existence of this slide.

There may be some possible processes of breach (initiation of overflow) such as the case of the slide No.1, No.2 combined with the secondary downstream slide and the case of the downstream slide caused by the reduction of water tightness in the upper embankment and others.

Considering the loss of upper embankment in the large areas in a short period, it was possible that these processes were combined resulting in a cause of overflow hence accelerated the velocity of erosion of the dam.

Notes: The solid lines are existing slide bodies. The broken lines are estimated slide bodies which were lost by wash-out.
