Review of the Cause of Fujinuma-ike Failure

--Summary Report--

January 25, 2012

Panel to evaluate the seismic stability of dams and small ponds for agricultural purpose of Fukushima Prefecture

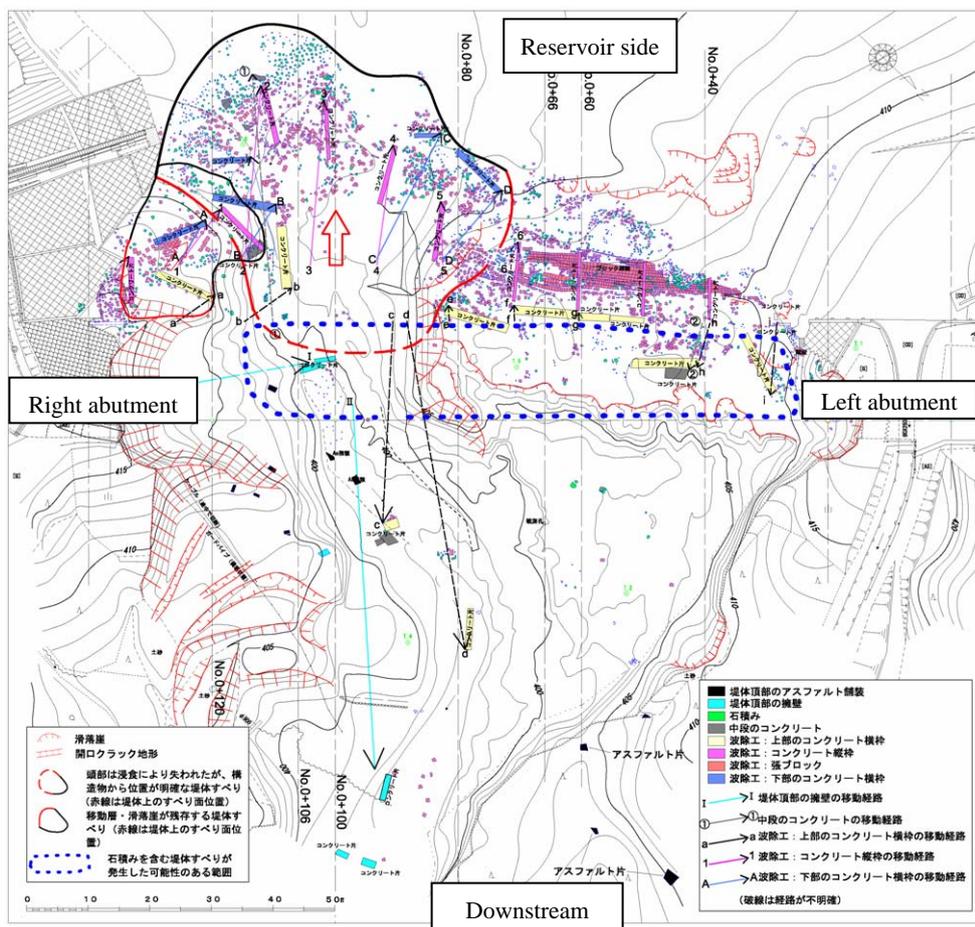
Figure 1. Mapping of structural elements after failure

- (1) Most of upper part of embankment was washed away and most of middle and lower part of downstream embankment was also washed away.
- (2) From the movement of the structural elements, firstly, masonry riprap of upper part of embankment fell to the reservoir and subsequently the surface protection work from the middle to the right abutment moved substantially to the reservoir (Figure 1).
- (3) It was confirmed that slides occurred in the direction both of the reservoir and downstream judging from the distribution of main scarps, sliding surfaces and moved layers in Fujinuma Dam (Figure 2).
- (4) In the auxiliary dam, the main slide with the width of 55 meter, length of 25 meter and depth of more than 3 meter occurred and the secondary slide happened at its front (Figure 3).

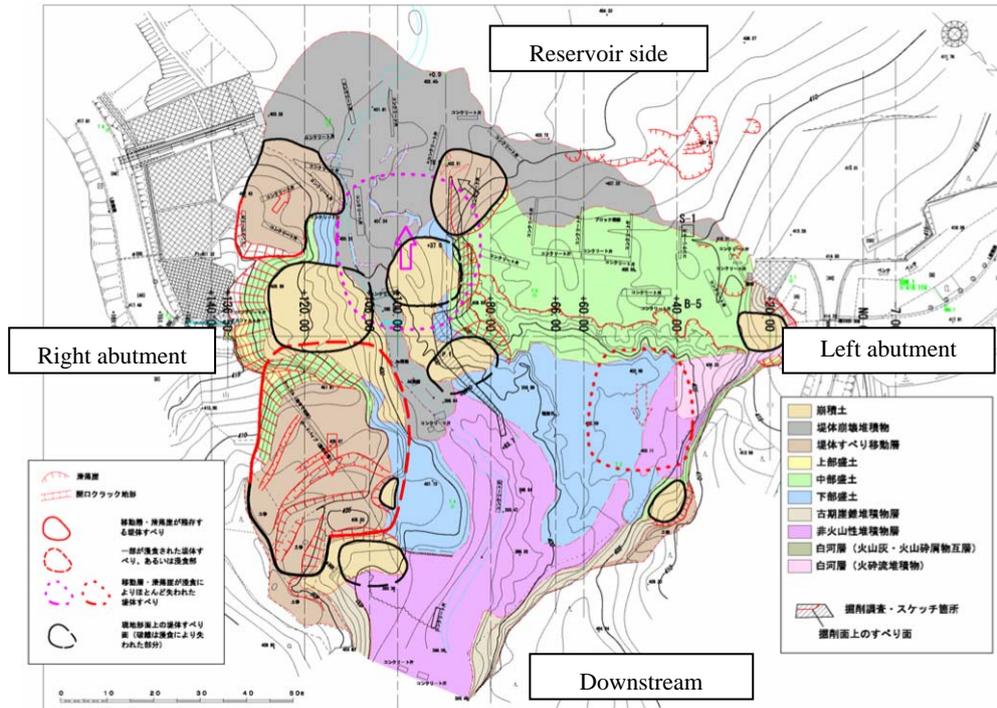
Figure 2. Possible slides estimated from geologic and topographic mapping

Notes: Encircled lines indicate the slide block.

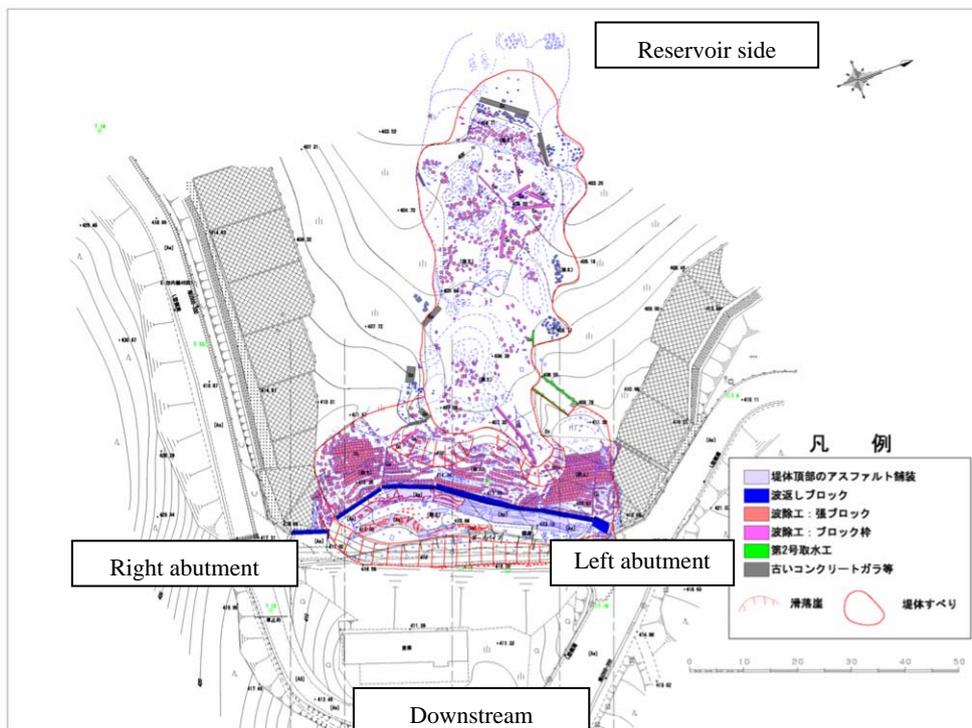
Figure 3. Damage of structure and slides of auxiliary dam

(3) The slide occurred in the auxiliary embankment consisting of similar material to upper embankment of main dam and one of its failure causes is the nature of the soil of embankment, rich with sandy materials.

(4) In the slide occurred in the auxiliary dam, sliding surface was restricted to the embankment boundary of the different construction periods. In the main dam, the difference of the degree of compaction depending on the different construction periods is possibly attributable to the occurrence of the sliding.

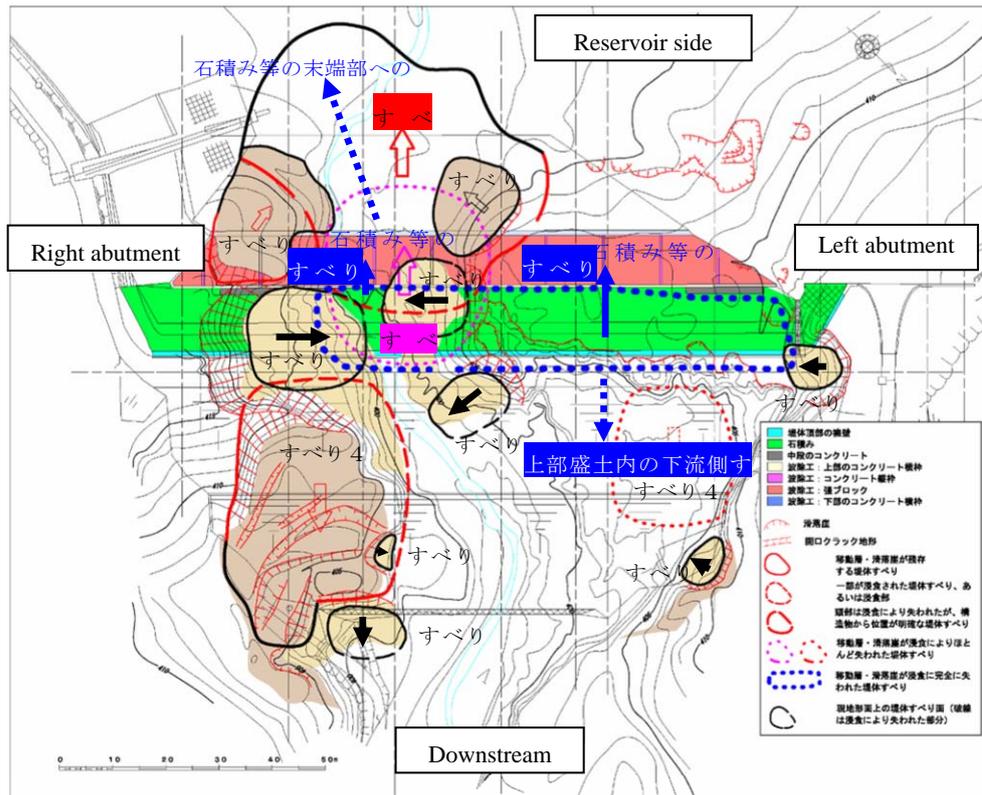
Figure 4. Integrated map of slides of Fujinuma main dam

Summing up the investigation results, slides are broadly classified to seven stages (Figure 4). Among these slides, the upstream slide No.1 and No. 2 triggered the subsequent overflow and erosion and resulted in a failure of the dam. The slide No.1 occurred in the upper embankment and it was recognized from the remnant of the structural elements in the reservoir and sliding surface was lost by wash-out. However, the earthquake deformation analysis (by modified Newmark procedure) considering the strength reduction due to cyclic loading indicated the existence of this slide.

There may be some possible processes of breach (initiation of overflow) such as the case of the slide No.1, No.2 combined with the secondary downstream slide and the case of the downstream slide caused by the reduction of water tightness in the upper embankment and others.

Considering the loss of upper embankment in the large areas in a short period, it was possible that these processes were combined resulting in a cause of overflow hence accelerated the velocity of erosion of the dam.

Notes: The solid lines are existing slide bodies. The broken lines are estimated slide bodies which were lost by wash-out.
