The 2011 Tohoku earthquake and dams

N. Matsumoto & T. Sasaki
Japan Dam Engineering Center, Japan

ABSTRACT: The magnitude 9.0 Tohoku earthquake occurred on March 11, 2011 near the northeast coast of Japan. The earthquake and tsunami caused enormous damage to Japan. As of April 8, 12,731 people were dead, 14,706 people are still missing and 216,818 houses or buildings were damaged or destroyed (National Police Agency, NPA). Fukushima No.1 nuclear power station had accidents. This paper is a preliminary report of the behavior of dams during the earthquake.

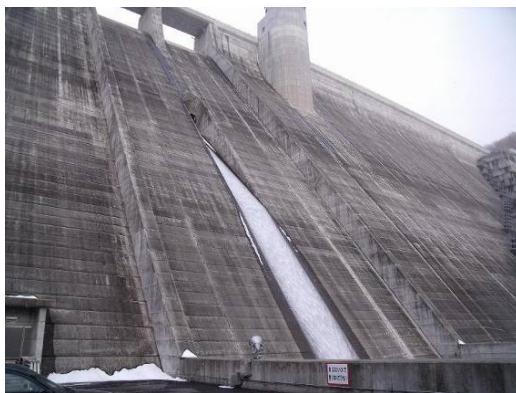
At the time documenting this paper, it is impossible to describe the performance of all dams in the affected areas during this earthquake. This is a very preliminary report. Figure 3 sows the location of major dams and the projection of fault surface. Iwate, Miyagi and Fukushima are severely affected three prefectures. The shortest distance to the fault of these dams ranges 70 to 160 km, if the dip of the fault is taken into account. Figure 4 is Takou dam in Iwate Prefecture. The dam performed very well, but the gate house was cracked as shown in Figure 5. Figure 6 is the photo of crest of Nanakita dam in Miyagi Prefecture. Three filldams suffered cracking in asphaltic concrete face. Minamikawa Saddle dam is one of them as shown in Figure 7.

Figure 4. Takou Dam after the quake

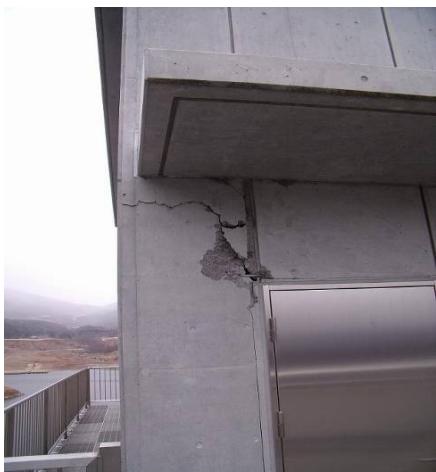
Figure 5. Cracking at gate house

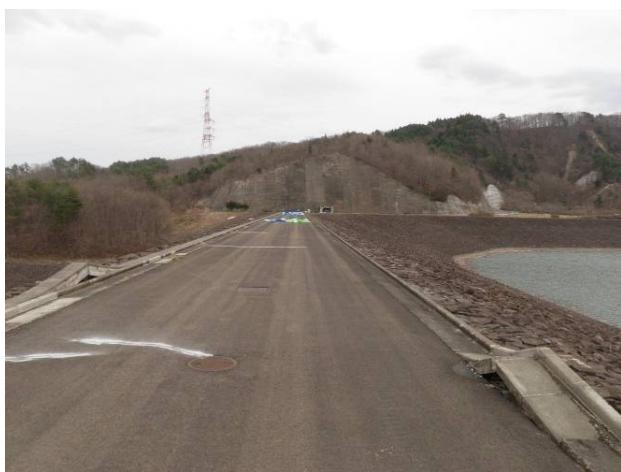
Figure 6. Bump on the crest of Nanakita Dam

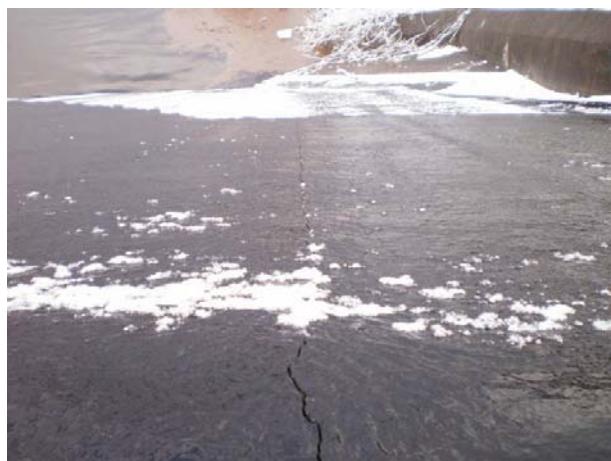
Figure 7 Asphaltic concrete face of Minamikawa Saddle Dam

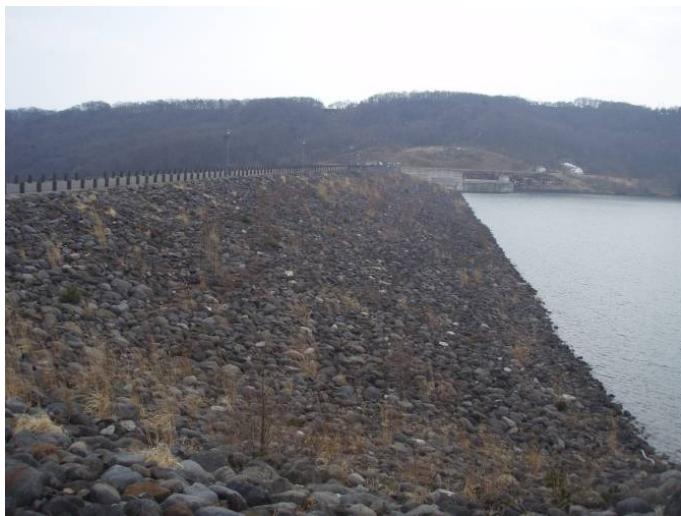
Japan Society of Dam Engineers (JSDE) sent a field investigation team to several dams in Fukushima Prefecture on March 29 and 30, 2011. The study team consisted of three engineers of N. Matsumoto, T. Sasaki and H. Amamiya. They met local officials of Fukushima Prefecture and Sukagawa City. Hokkawa Dam is a 57 meter high gravel fill dam for flood control, environmental water and municipal water. A leakage increase slightly, but it looked in good shape as shown in Figure 9. Hatori-ko (“ko means lake) is a 37.1 meter high earthfill dam which was completed in 1956 for irrigation. Its reservoir capacity is 27 Mm³. The dam crest and downstream slope were protected by tarp to prevent rain percolation as shown in Figure 10. Nishigo dam is also a 32.5 meter high earthfill dam for irrigation. Figure 11 is its dam crest which suffered longitudinal cracking. There was bump on the upstream slope and the reservoir water was withdrawn for the safety of the dam after the earthquake. Akasaka dam and Yanome dam are an earthfill structure and also suffered cracking on the crest.

Figure 9. View of Hokkawa dam from left abutment towards right abutment

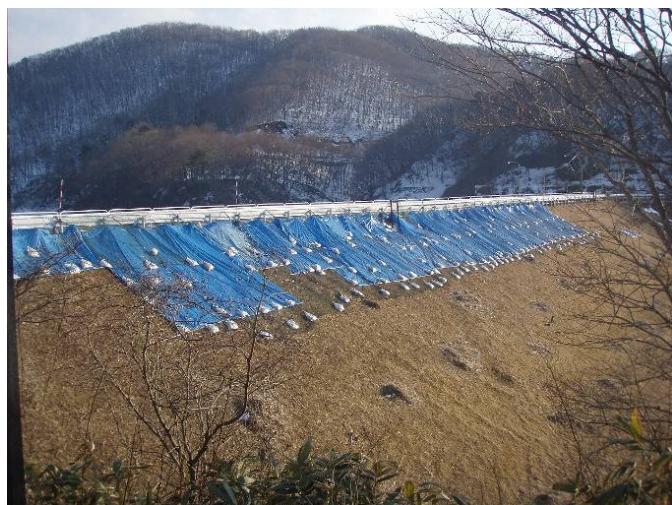
Figure 10. Hatoriko downstream slope

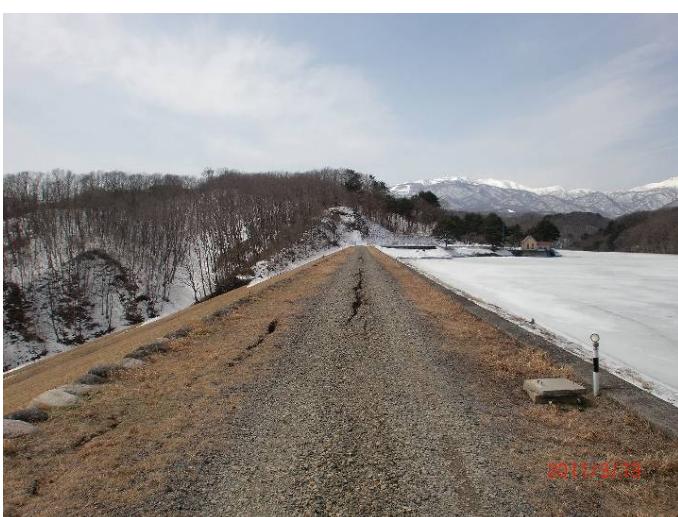
Figure 11. Nishigo Dam; cracking on the crest

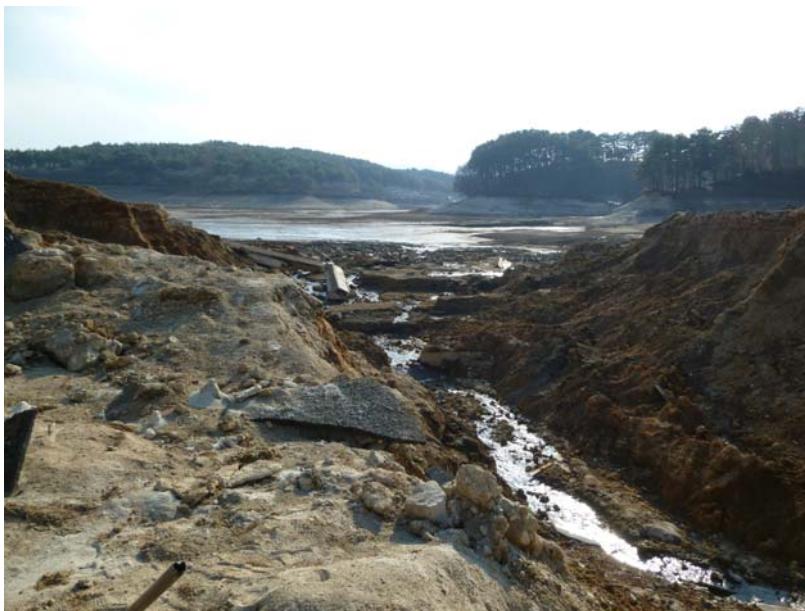
Fujinuma-ike was breached shortly after the earthquake. It is located in the southern Fukushima Prefecture. The epicentral distance is about 240km and the shortest distance to the fault is about 80km, in case the NIED fault model is employed. The accelerometer were not installed at the site. The attenuation relationship obtained from NIED strong motion network indicates that PGA at ground surface of the same fault distance is around 0.2 to 0.7g. According to the local officials of the irrigation department, 8 people were dead and 9 houses were swept. Fujinuma-ike is an earthfill structure with the height of 18.5 m as shown in Figure 12. The crest length is 133m, crest width is 6m and reservoir capacity is 1.5Mm³. Spillway is ungated.

Construction began in 1937 for irrigation and was suspended during World War II. It was completed in 1949. When the earthquake occurred, the reservoir level was almost full. According to witness, 20 to 25 minutes after the earthquake, the water was overflowing on the crest. Later big discharge occurred and it was breached completely as shown in Figures 13 & 14. The embankment had lost the height to retain water. The structure is a homogeneous type and most materials seem to be cohesive soil.

Figure 13. View from downstream toward the Fujinuma-ike

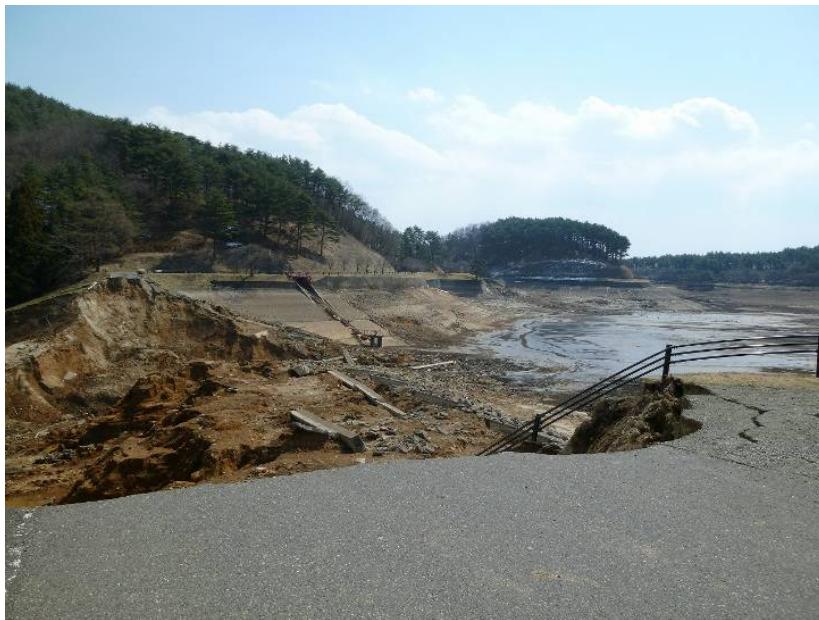
Figure 14. View from left abutment toward the breached portion
