# REHABILITATION OF AN OLD CONCRETE GRAVITY DAM AND ITS COUNTERMEASURES FOR ENVIRONMENTAL PRESERVATION

**Abstract:** The Chugoku Electric Power Co., Inc. rehabilitated an old concrete gravity dam, which was completed in 1924, with the aim of improving flood discharge capacity and seismic stability, together with the re-development of existing hydropower station.

In this rehabilitation, an additional spillway was installed, and the new concrete was placed on the downstream face of existing dam body.

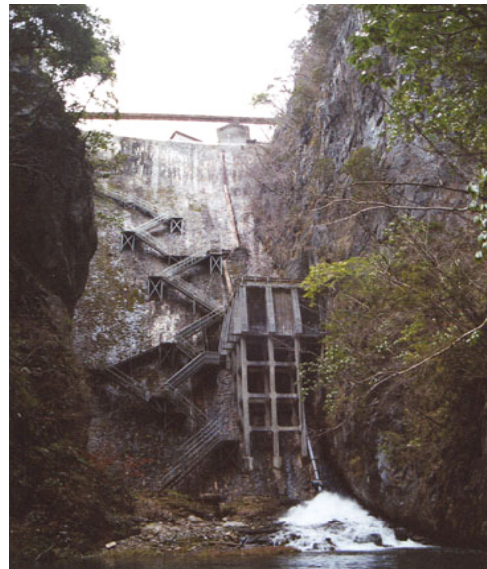
Fig. 1 The Taishakugawa dam  
(Before rehabilitation)

However, as the reasons bellow, the Taishakugawa dam was planed to improve to be a modern dam by the drastic rehabilitation together with the re-developing existing hydropower station.

- An insufficient flood discharge capacity of the spillway had restricted the operation of the reservoir.
- There was an unused head of about 35 m in the maximum and effective utilization of valuable water resource was not performed enough.

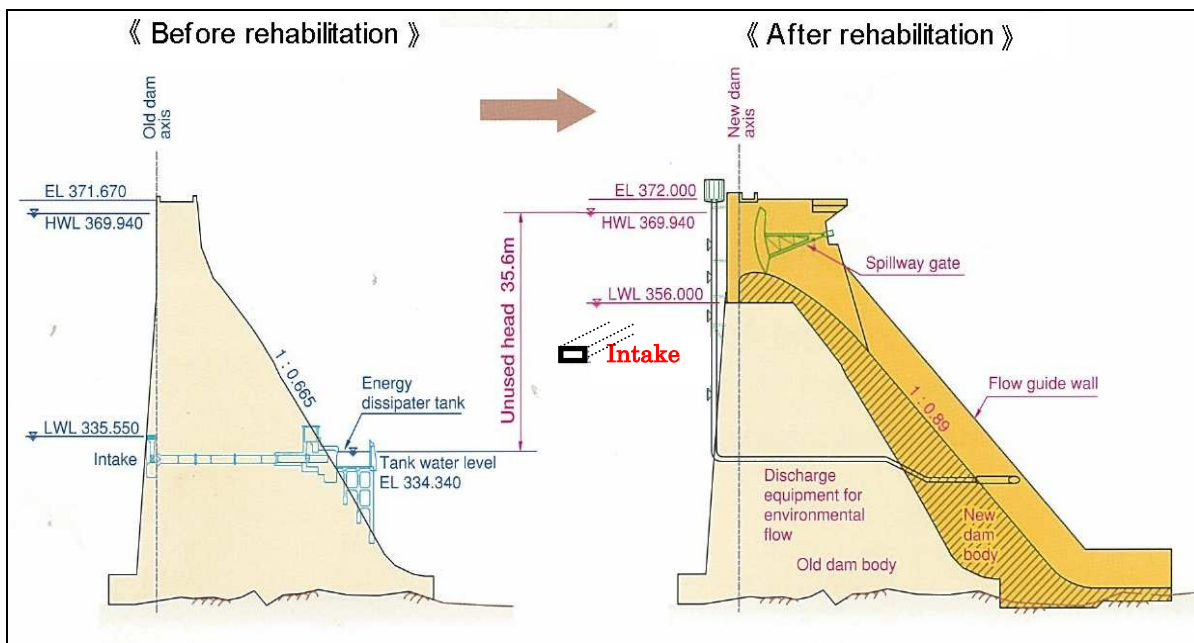
Fig. 3 Cross section of the dam rehabilitation work

The rehabilitation work of the Taishakugawa dam is outlined in Fig. 3. The upper part of the existing dam body was cut off so that the overflow type spillway was installed on the top of the dam for the improvement of flood discharge capability and new concrete was added on the downstream face of existing dam body for the improvement of seismic stability. Table 1 shows the dimensions of the Taishakugawa dam before and after rehabilitation.

The existing spillway is tunnel type, located separately from the dam body with flood discharge capacity of 720m<sup>3</sup>/s. As the possibility of flooding far greater than the discharge capacity of existing spillway was confirmed by the runoff analysis based on the recent torrential rainfall records, reservoir level had been lowered during flood seasons. However, for the drastic solution of insufficiency of the discharge capacity, conclusion was reached that the top of the existing dam body needed to be cut off, so as to install an overflow type spillway on the top of it.

The Taishakugawa dam was designed and constructed over 80 years ago and therefore does not satisfy the specific safety requirements (seismic stability) of the current design criteria in Japan. In order to satisfy the current safety level of the dam, it was planned that the new concrete was placed on the downstream face of existing dam body.

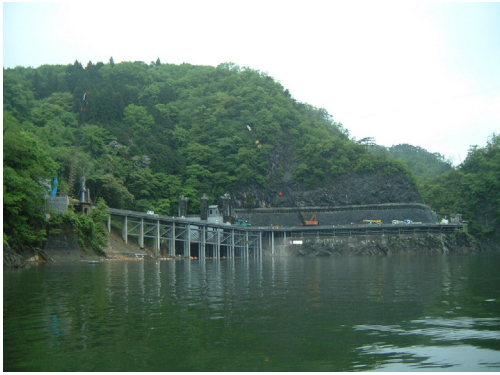
According to the circumstances above mentioned, Steel-made temporary road of about 170m was set in the reservoir because there was no road by which the vehicles for construction was able to access to the dam site (See Fig.6). Moreover, the dam concrete was placed by setting up similar steel-made temporary stage (43m in maximum height) on the downstream of the dam (See Fig.7), and by using 80t crawler crane.

Fig. 6 Steel-made temporary road in the reservoir

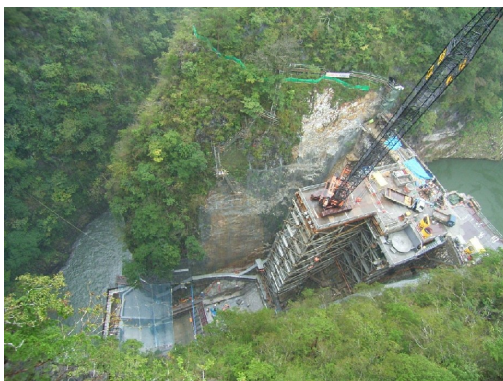
Fig. 7 Steel-made temporary stage on the downstream of the dam
