PRELIMINARY INVESTIGATION OF DAMS STRICKEN BY THE IWATE-MIYAGI NAIRIKU EARTHQUAKE IN 2008

Yoshikazu YAMAGUCHI and Tomoya IWASHITA

Public Works Research Institute, Japan, e-mail: yamaguti@pwri.go.jp, iwashita@pwri.go.jp

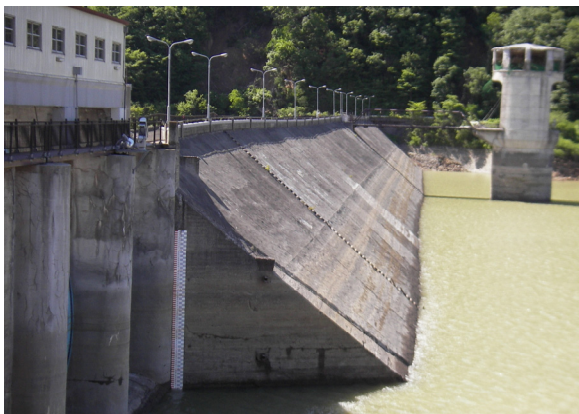
Ishibuchi Dam is a concrete faced rockfill dam (CFRD) with a dam height of 53m completed in 1953, and managed by Tohoku Regional Bureau, MLIT. Figure 3 is the cross section and longitudinal section of the dam. The upstream concrete face maintains the watertightness of dam body of this type of dam. No severe damage was found in the concrete face and its joints shown in Photo. 1.

Photo.1 Concrete faced upstream slope on which no damage was found (Ishibuchi Dam) (Photographed by Public Works Research Institute (PWRI) on June 15, 2008)

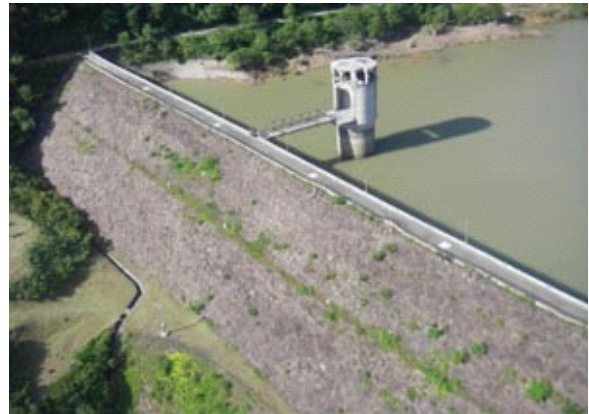
At the crest of the dam, the pavement was waved and cracked shown in Photos. 2 and 3. And gaps appeared on the boundary between the railing and pavement on the shoulder of the slope

Photo.2 Overview of the crest and downstream slope (Ishibuchi Dam) (Photographed by PWRI on June 15, 2008)

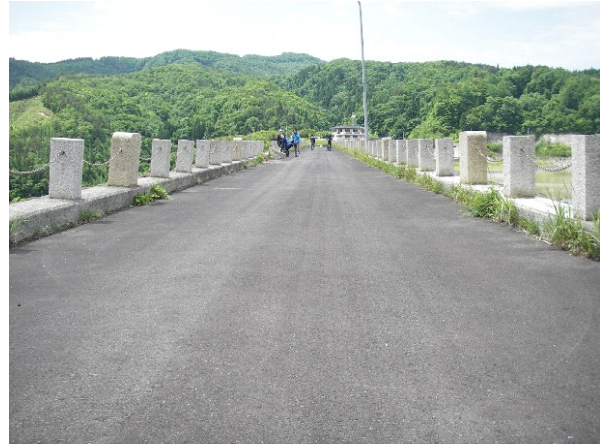
settlement occurred at the core zone in the center of the crest rather than at the rock zone. Regardless of the large settlement, no conspicuous cracks were found on the crest pavement surface shown in Photo. 9. In addition, no deformation of the riprap on the upstream and downstream surfaces was found.

Photo.9 Few cracks in the crest pavement in spite of the dam body settlement (Aratozawa Dam) (Photographed by PWRI on June 16, 2008)

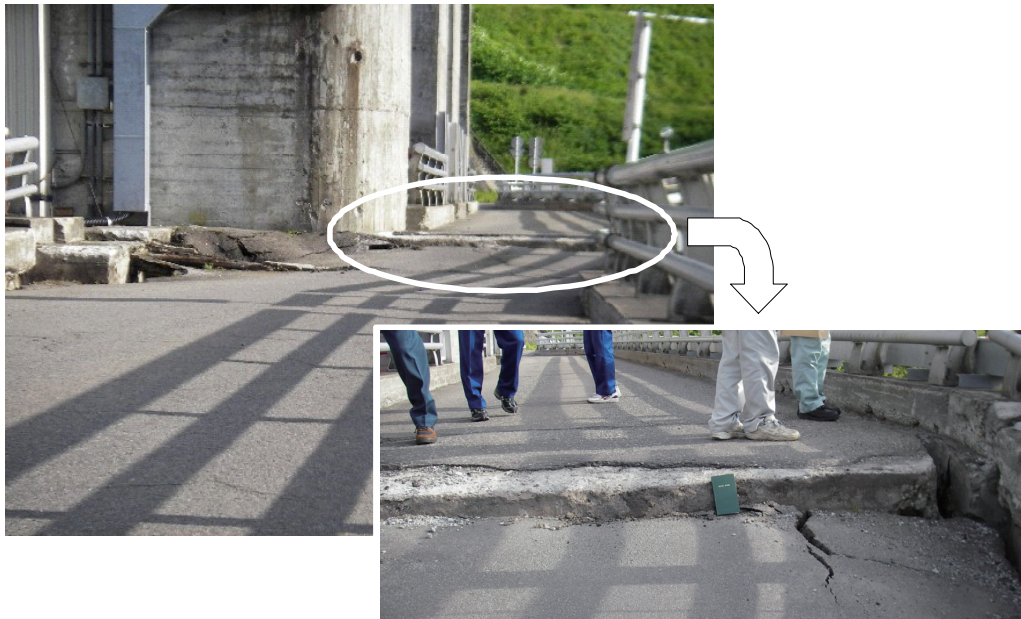
No cracks were confirmed on the pavement at the crest. Crest settlement of about maximum 14cm was observed, and at the connection of the spillway and the rockfill dam body, a level difference of about 15cm formed shown in Photo.

10. No deformation was confirmed on the upstream facing and the downstream rock slope surface.

Photo.10 Level difference occurred at the connection of the spillway concrete and the rockfill dam body as a result of the settlement of the dam body (Minase Dam) (Photographed by PWRI on June 15, 2008)
