Performance of Zipingpu CFRD during the strong earthquake

Xu Zeping

(China Institute of Water Resources and Hydropower Research)

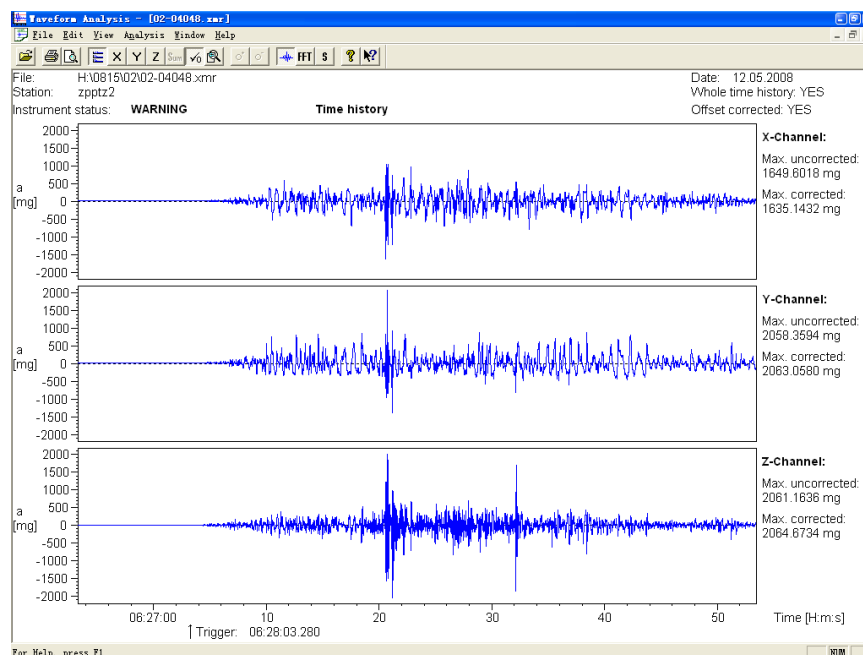
Figure 4 Accemerogram recorded at the center of dam crest

During the earthquake, the accelerometer recorded at the center of dam crest is shown in Figure 4. It can be noticed that the acceleration at dam crest has reached 2g. Considering the normal amplification factor, the ground acceleration should be larger than 0.5g, which is far more beyond the intensity

accepted by the design.

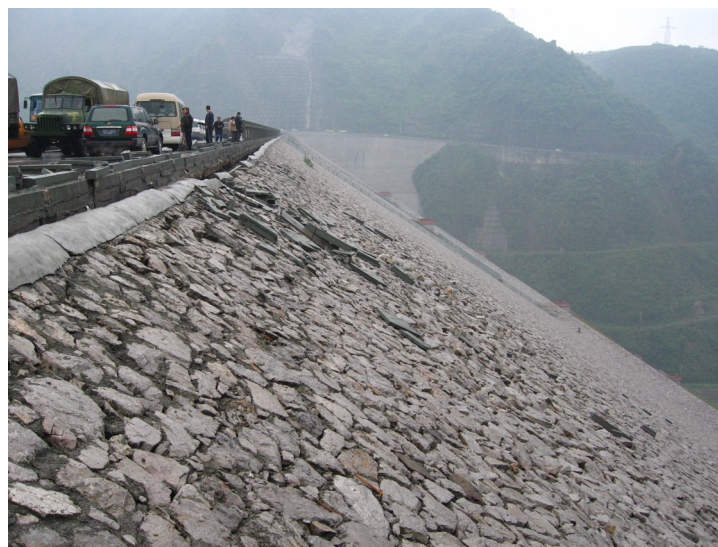
Figure 5 Settlement of dam crest

During the earthquake, significant deformation was occurred on the dam. Immediately after the earthquake, an obvious settlement of dam crest in riverbed section could be identified even by eye view (Figure 5). From the measurement of the mark points of dam crest, dam crest has a significant settlement in the moment of earthquake. The maximum settlement value is 683.9 mm and it is located at the river center section. After the main earthquake, the observed settlement of dam crest still developed. But the rate of settlement dropped rapidly. On May 12, the

maximum settlement of dam crest reached to 744.3 mm. On May 22, the settlement of dam crest was basically stable. The maximum displacement of dam crest in the direction of river flow is 199.9 mm, towards downstream direction. The position of the maximum displacement located at riverbed section. For the displacement in the direction of dam axis, the rockfill of abutment areas are trend to move to the center of the river. The maximum horizontal displacement towards right abutment is 226.1 mm and the maximum horizontal displacement towards left abutment is 106.8 mm.

From the observed data of the settlement inside the dam, it can be noticed that the settlements of rockfill are increased with the rising of elevation. Higher elevation presents more deformation and settlement. On EL. 760 m, the settlement at dam axis due to the earthquake is 106.0 mm. On EL. 820 m, the settlement at dam axis is 322.5 mm. On EL. 850 m, the settlement at dam axis is 810.3 mm.

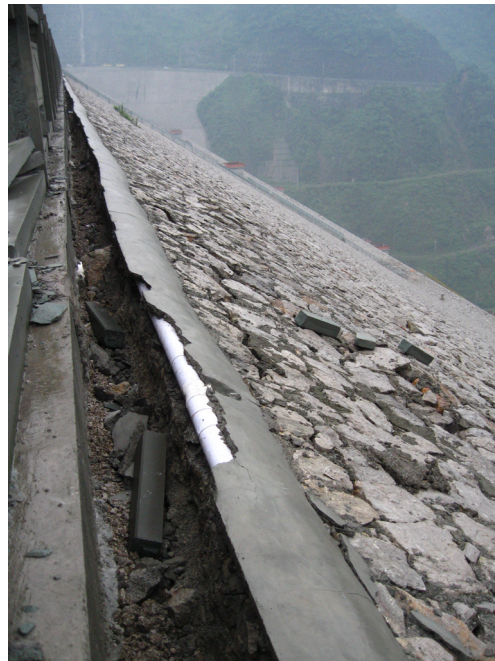
Figure 6 Crack at the downstream side of dam crest

During the earthquake, the downstream part of rockfill dam has a relatively larger displacement. On El. 766 m, El. 795 m, El. 824 m and El. 854 m, the observed horizontal displacement towards downstream direction are 69.8 mm, 166.9 mm, 260.5 mm and 274.4 mm respectively. The observed maximum horizontal displacement towards downstream direction at dam crest is 199.9 mm. So there is a big crack along the downstream side of the crest road (as shown in Figure 6).

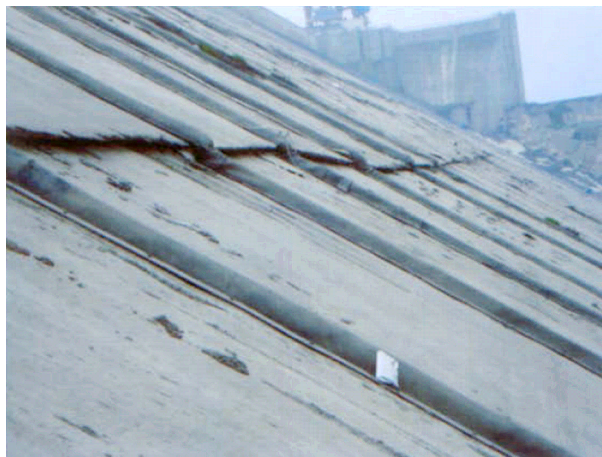
Figure 7 The overlapping of the second stage and third stage face slabs

The strong earthquake has produced certain damage on concrete face slab, which include the cracks and ruptures of the face slab. On El. 845 m, where is the construction joint of the second stage face slab and third stage face slab, the face slabs are overlapped (as shown in figure 7). The height of the overlapping is 150 mm~170 mm and the reinforcement across the joint is bended into “Z” shape.

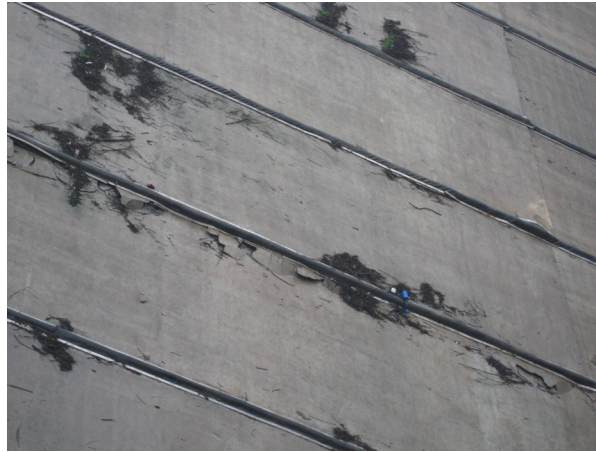
Figure 8 Rupture of concrete slabs along vertical joint

Along the vertical joint of the face slab 5 and 6 (left abutment) and the face slab 23 and 24 (riverbed), concrete face slabs were ruptured by the action of large compression stress along dam axis. From figure 8, the spalling of concrete can be noticed.

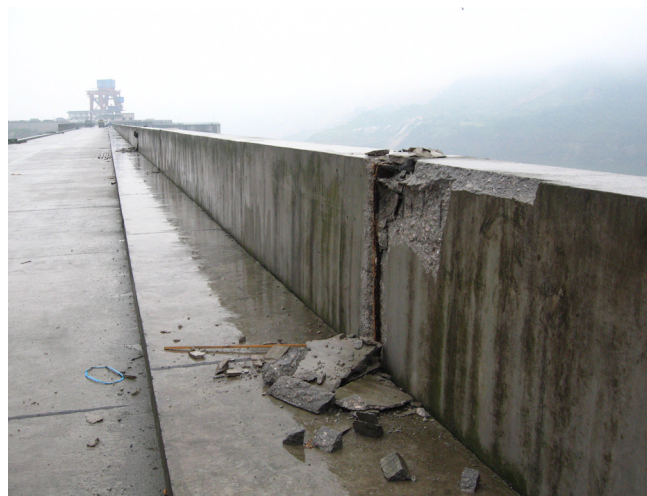
Figure 9 Rupture of parapet wall in riverbed section

As the maximum dynamic response of the dam occurred at dam crest, the quake caused many cracks and ruptures of the parapet wall. Near the abutment, the originally closed joints were opened. In riverbed section, the parapet wall was ruptured by large compression stress (as shown in Figure 9).

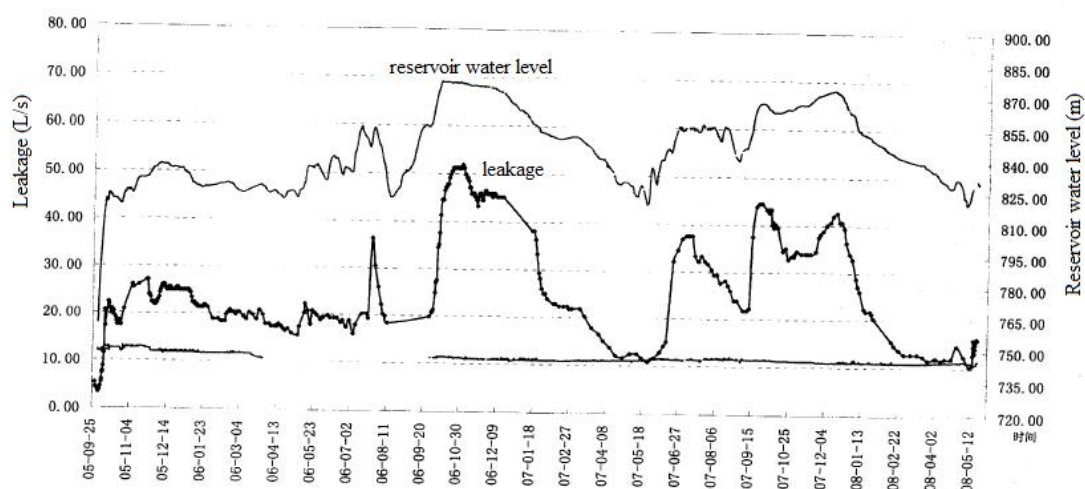
Figure 10 Leakage of the dam

The leakage observation of the dam is shown in Figure 10. It can be noticed that the dam leakage has a close relationship with reservoir water level. Before the earthquake, the leakage of the dam is 10.38 L/s (May 10). After the earthquake, the leakage of the dam was increased to 19 L/s. The first two days of after earthquake, the seepage water was turbid. Now the seepage water becomes clear.
