A CLEAR WATER BYPASS PIPELINE SYSTEM MITIGATES TURBID WATER DISCHARGE FROM A DAM

Japan Water Agency, Arakawa Dam Construction Operation and Management Office,

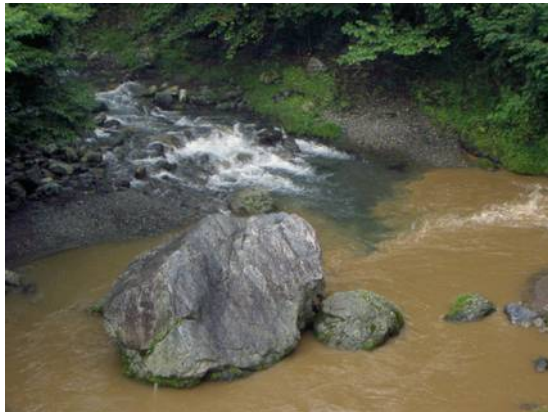
Fig.2 Turbid Inflow

The dam was completed in 1999 and soon experienced high turbidity of inflow due to intense rainfall from typhoons. Most of the entire catchment area was steep forested slopes,

some poorly maintained, and heavy rain resulted in severe soil erosion. (Fig.2)

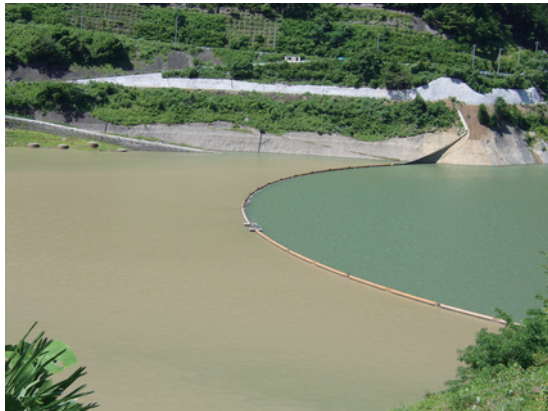
Fig.3 Floating Turbidity Curtain

Before the dam construction, the inflow of turbid water was thought to be manageable with a floating turbidity curtain and an intake tower with depth-selective withdrawal. (Fig.3) However, the recession of forestry resulted in poor forest maintenance and unexpected inflow levels of highly turbid water. In addition, an increase in wildlife population damaged the forest and the ground surface.

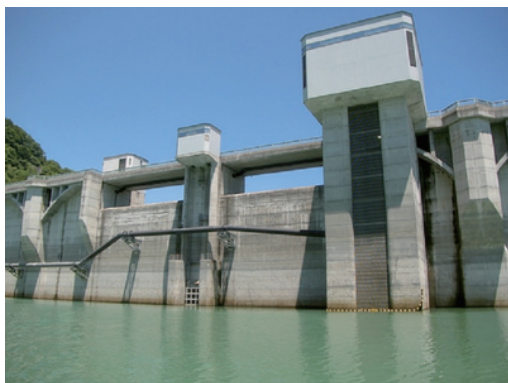
Fig.15 Outlet (1)
(Intake Tower)

As power generation is one of the purposes of the Urayama Dam, it is necessary that the operation of the bypass pipeline does not reduce power generation. Therefore the outlet had to be installed upstream of the power station to avoid any head loss. (Fig.15)

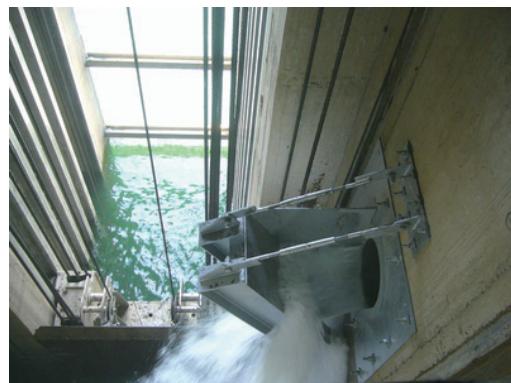
Fig.16 Outlet (2)
(Inside the Intake Tower)

The outlet was located in a selective intake tower in the reservoir. The tower had been originally equipped with gates that allowed the separation of the water inside from reservoir water. Water from the bypass pipeline is poured directly into the inside of the tower, without mixing with turbid reservoir water. (Fig.16)
