The 2011 Tohoku earthquake and dams

N. Matsumoto & T. Sasaki
Japan Dam Engineering Center, Japan

ABSTRACT: The magnitude 9.0 Tohoku earthquake occurred on March 11, 2011 near the northeast coast of Japan. The earthquake and tsunami caused enormous damage to Japan. As of April 8, 12,731 people were dead, 14,706 people are still missing and 216,818 houses or buildings were damaged or destroyed (National Police Agency, NPA). Fukushima No.1 nuclear power station had accidents. This paper is a preliminary report of the behavior of dams during the earthquake.

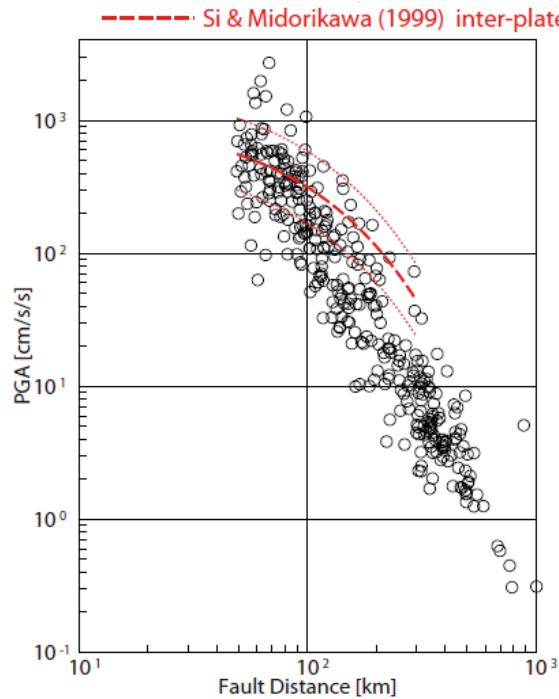
National Institute of Earth Science and Disaster Prevention (NIED) recorded strong motion at about 400 locations. Figure 1 shows PGA and the shortest distance to the fault. Peak ground accelerations in excess of 1.0g were measured at about 10 locations. Strong motion was also recorded at more than 70 dams. PGA at dam foundations ranges mostly 0.1 to 0.5g in three prefectures of Iwate, Miyagi and Fukushima. Figure 2 shows the comparison of PGA at dam foundations and NIED ground motion of past earthquakes (Matsumoto). The figure indicates that PGA at dam foundation is about half of PGA of NIED ground motion reflecting the nature of ground conditions. Therefore, the measured PGAs at dam foundations are consistent with the PGAs recorded by NIED.

Figure 1. PGA and Fault Distance (NIED)

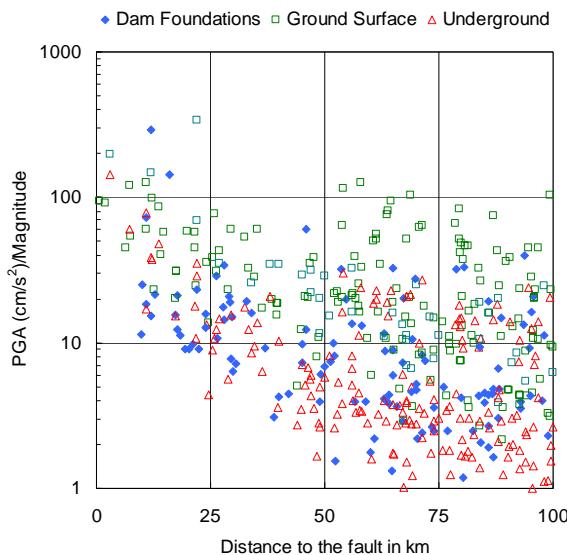
Figure 2. Comparison of PGA attenuation between dam foundations and NIED records in the past earthquakes (Matsumoto)

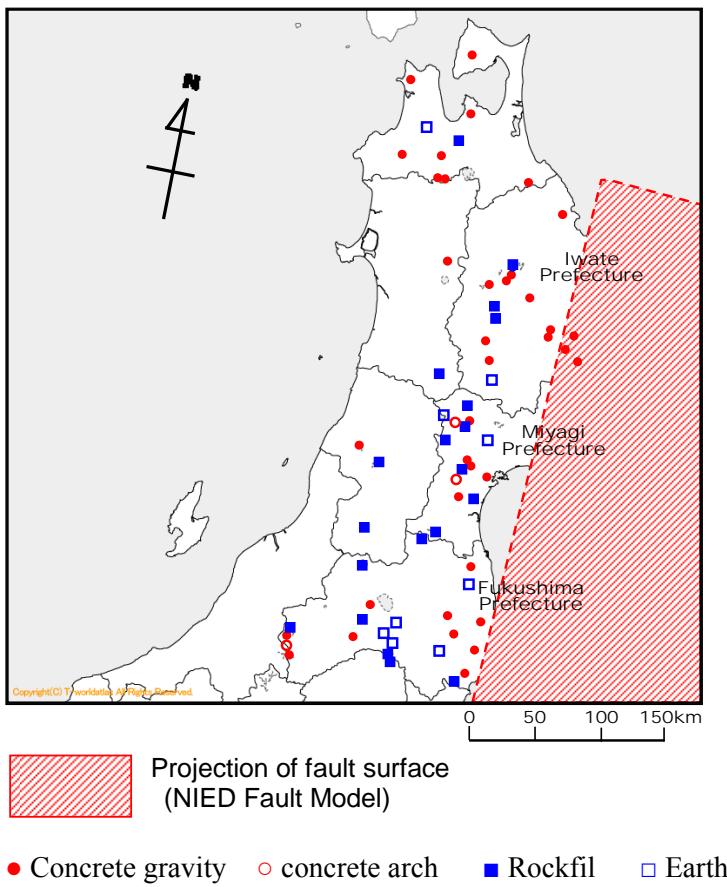
Figure 3. Location of major dams in affected area

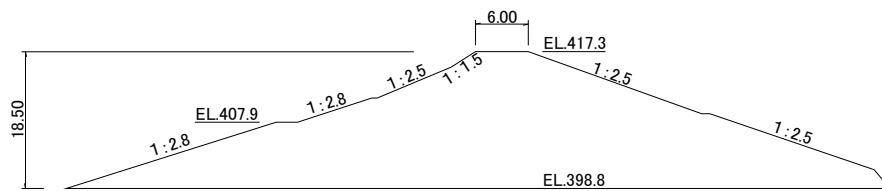
Fujinuma-ike was breached shortly after the earthquake. It is located in the southern Fukushima Prefecture. The epicentral distance is about 240km and the shortest distance to the fault is about 80km, in case the NIED fault model is employed. The accelerometer were not installed at the site. The attenuation relationship obtained from NIED strong motion network indicates that PGA at ground surface of the same fault distance is around 0.2 to 0.7g. According to the local officials of the irrigation department, 8 people were dead and 9 houses were swept. Fujinuma-ike is an earthfill structure with the height of 18.5 m as shown in Figure 12. The crest length is 133m, crest width is 6m and reservoir capacity is 1.5Mm³. Spillway is ungated.

Construction began in 1937 for irrigation and was suspended during World War II. It was completed in 1949. When the earthquake occurred, the reservoir level was almost full. According to witness, 20 to 25 minutes after the earthquake, the water was overflowing on the crest. Later big discharge occurred and it was breached completely as shown in Figures 13 & 14. The embankment had lost the height to retain water. The structure is a homogeneous type and most materials seem to be cohesive soil.

Figure 12. Typical section; dimension in meter
