PRELIMINARY INVESTIGATION OF DAMS STRICKEN BY THE IWATE-MIYAGI NAIRIKU EARTHQUAKE IN 2008

Yoshikazu YAMAGUCHI and Tomoya IWASHITA

Public Works Research Institute, Japan, e-mail: yamaguti@pwri.go.jp, iwashita@pwri.go.jp

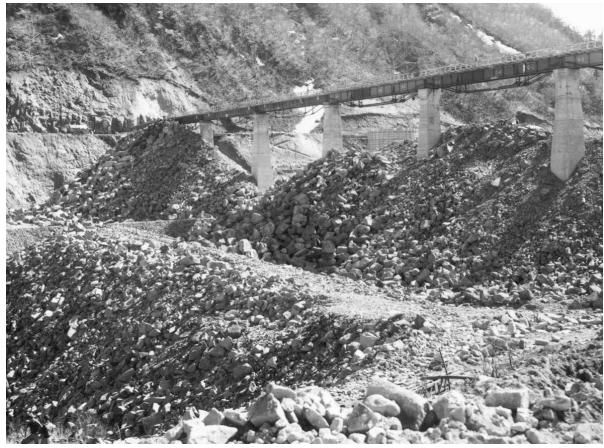
at the crest. On the downstream slope surface of the dam, projections were observed on the rock materials at the protruding parts of the wave on the crest pavement shown in Photos. 4 and 5, but damage of this kind was limited to high elevations. This dam was constructed by the dumped rock construction method as shown in Photo. 6 taken during construction. The piers for the railroad from where trucks dropped rock materials were left buried in the dam body. It is hypothesized that the whole dam body settled due to the earthquake, while the areas near the buried piers only settled a little. The maximum differential settlement is supposed to be about 50cm.

Photo.6 Ishibuchi Dam under construction by the dumped rock method in 1950's (The piers of tramway were buried.) (Courtesy by Kitakami River Integrated Dam Management Office, MLIT)
