Performance of Zipingpu CFRD during the strong earthquake

Xu Zeping

(China Institute of Water Resources and Hydropower Research)

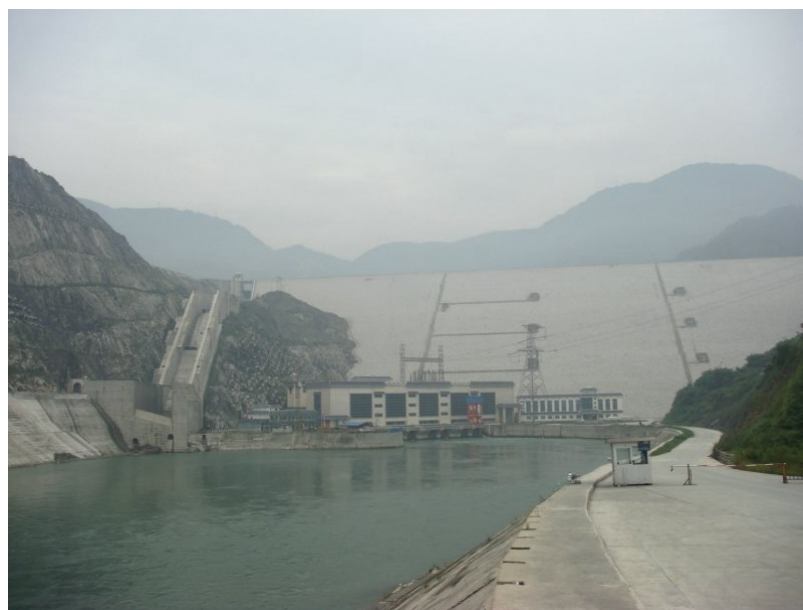
Figure 2 Zipingpu concrete faced rockfill dam

After careful inspection of the dam immediately after the earthquake, Zipingpu CFRD is considered structurally stable and safe. But the dam do sustained a range of damages during the quake, including cracks at the top and collapsed workshop.
