KYUSHU ELECTRIC'S ACTIONS TOWARDS BIODIVERSITY CONSERVATION IN DAM CONSTRUCTION FOR A LARGE-SCALE PUMPED STORAGE HYDROELECTRIC POWER STATION

Civil Engineering & Architecture Sec., Omarugawa Hydro Power Plant Construction Office,
Kyushu Electric Power Co., Inc.

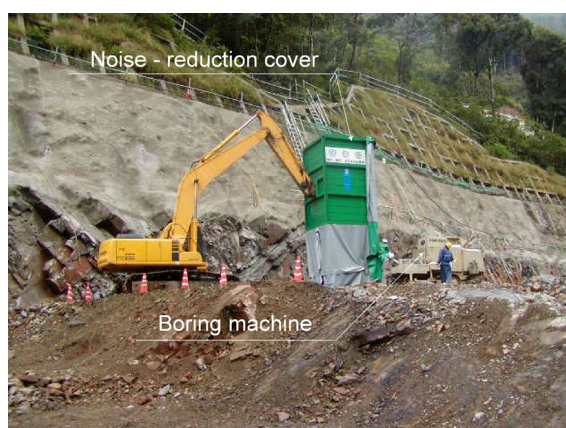
Photo 2. Installation of noise-reduction cover

Item	Content
Noise measure	Use of low-noise equipment	Applicable to construction equipment in general, i.e. backhoe
	Installation of silencer	Applicable to air bleeder of mortar sprayer
	Restriction on transport of excavated dirt	Restriction on height of loading bucket of backhoe from load-carrying platform of dump
	Installation of noise-reduction cover	Applicable to boring machine (Photo 2)
	Vehicle speed limit	Speed limited to 30km/h or less around site
	Limited blasting	Restriction on amount of explosives used per blasting
Visual measure	Installation of low brightness net	Applicable to mortar-sprayed slopes and concrete structures
	Selection of lamps	Adoption of eco-friendly, sodium lamps
	Lighting direction	Lamps arranged to avoid shining on the nesting area

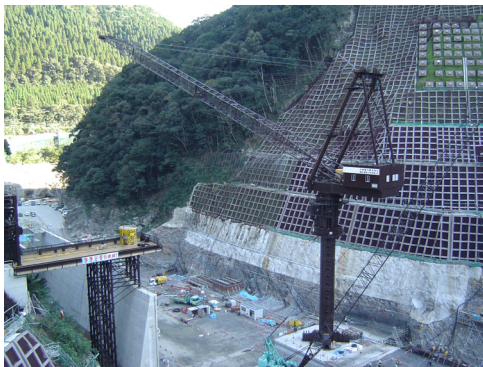
Photo 3. Low-brightness painting of tower crane

Concrete for the dam body was transported from the batching plant in a tailgate dump truck, and transfer car, then transferred by bunker lines to a bucket (4.5m³), which was then carried by a tower crane with an operating radius of 85 m and rated load of 10.7 t. Table 7 shows the conservation measures for the work:

Item	Content
Noise measure	Use of motor-driven equipment	Applicable to transfer car, boring machine, etc.
	Use of low-noise equipment	Applicable to vibrator and crawler crane, etc.
	Restrictions on equipment used	Limited use of small breaker and pick hammer, etc. (at nighttime during critical period)
		Limited use of whistle and siren, etc.
Visual measure	Restriction on lamp height	Limited lighting from high locations
	Restriction on lit area	Reduced lit area based on work conditions
	Installation of hood/louwer	Preventing light leakage from sodium lamps and adjusting beam direction
	Lighting direction	Lamps arranged to avoid shining on nesting area
	Use of localized lighting	Localized lighting during grouting
	Installation of low-brightness nets	Applicable to scaffold and concrete structures
	Adoption of low-brightness painting	Applicable to machinery such as tower crane and temporary building (Photo 3)
